Case 460 : Narrative

Case Vehicle (A): 2003 BMW
Type: Z4, 2-door convertible
Driver: 19-year-old male
CDC: 12-FYEW-2

Case 460: Vehicle Report

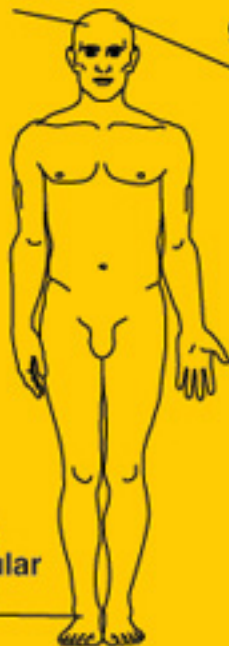
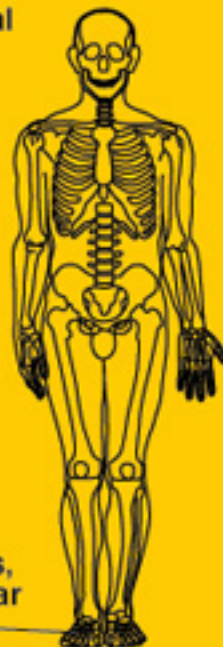
Closed head injury
with amnesia to the collision
(2)

17-cm laceration into the
galea, superior to left parietal
area of scalp
(2)

Disruption of the
distal right tibio-fibular
ligament
(2)

Open fractures,
right trimalleolar
(3)

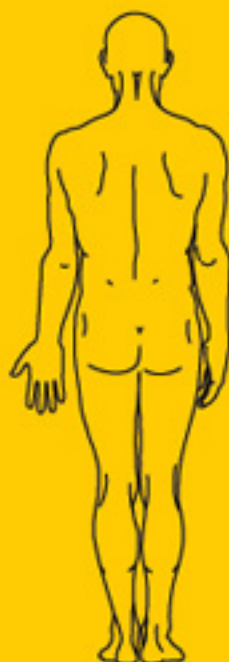
Laceration, knee
unknown aspect
(1)

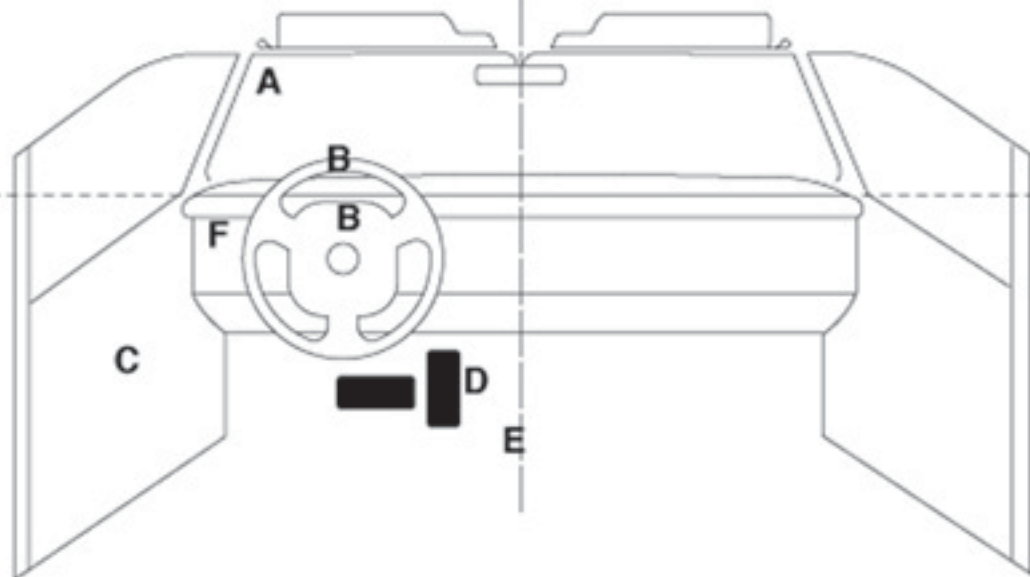
A = Windshield, spiderweb crack

B = Steering-wheel rim and hub, scuffmarks

D = Accelerator pedal, broken and displaced

F = Vent on upper IP, broken
